3M 820 Wet- Reflective Tape on SR-6 & I-215

Final Report

Experimental Feature X(02)12 – New Products

***Utah Department of Transportation
Research Division***

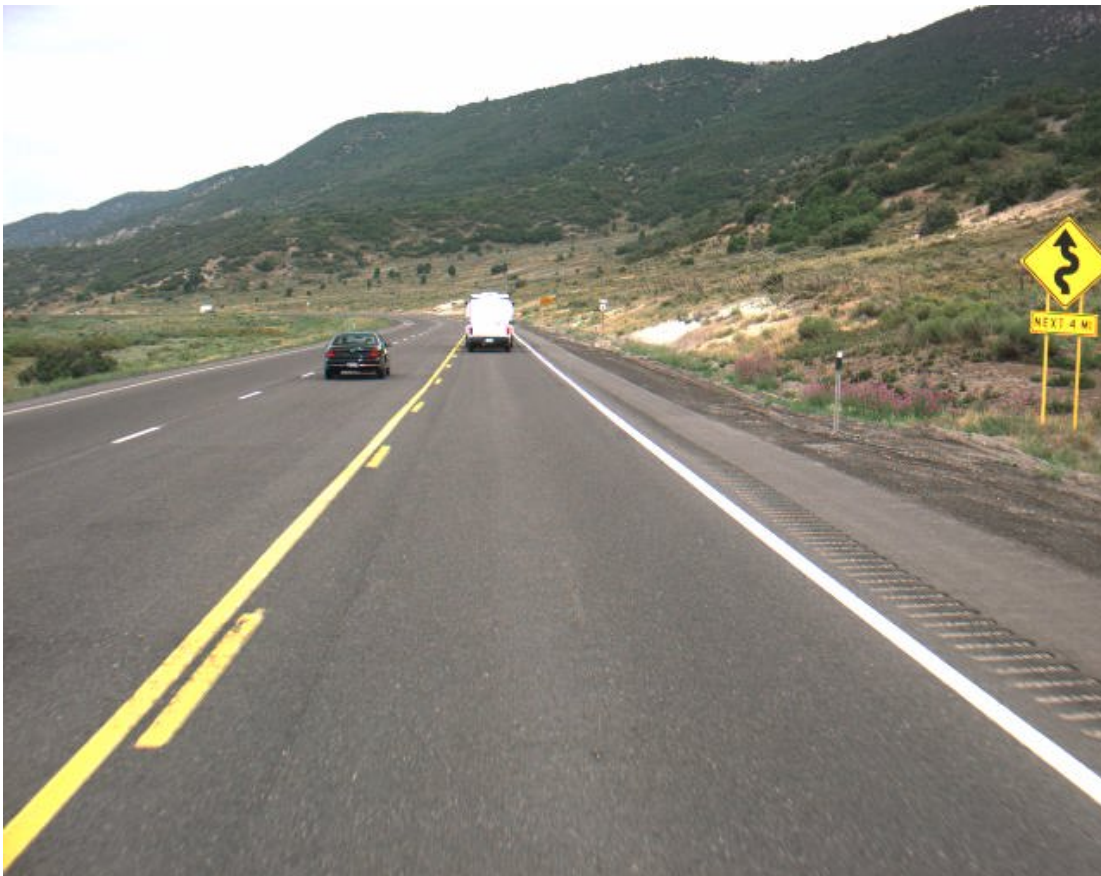
This 8-mile stretch of US-6 is primarily a three-lane (two EB, one WB) highway (see Figure 1), however it constricts to a two-lane highway at the beginning and end of the section.

Figure 1-Typical Section of US-6 (Heading WB)

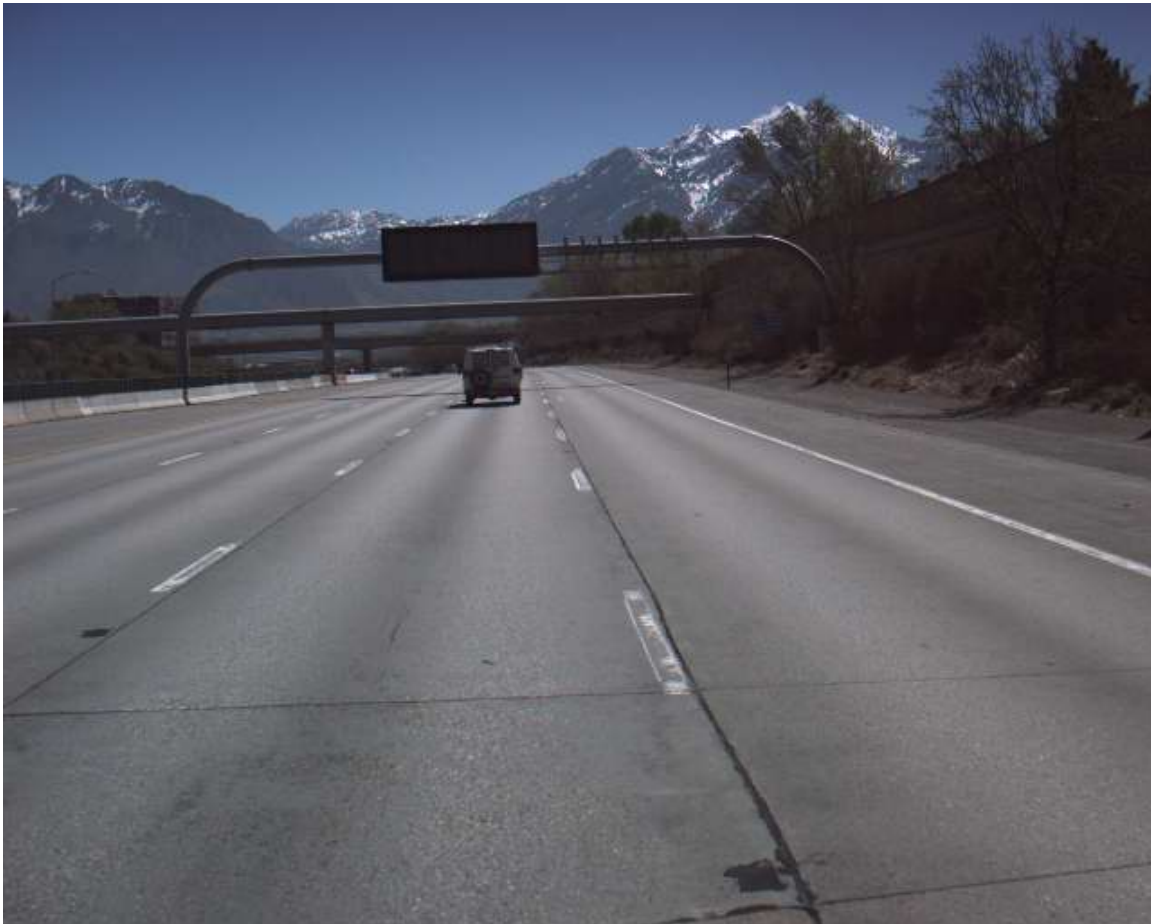
Interstate 215 is the belt route of Salt Lake City. At the test section location, the road is a six-lane divided interstate (see Figure 2).

Figure 2-Typical I-215 section

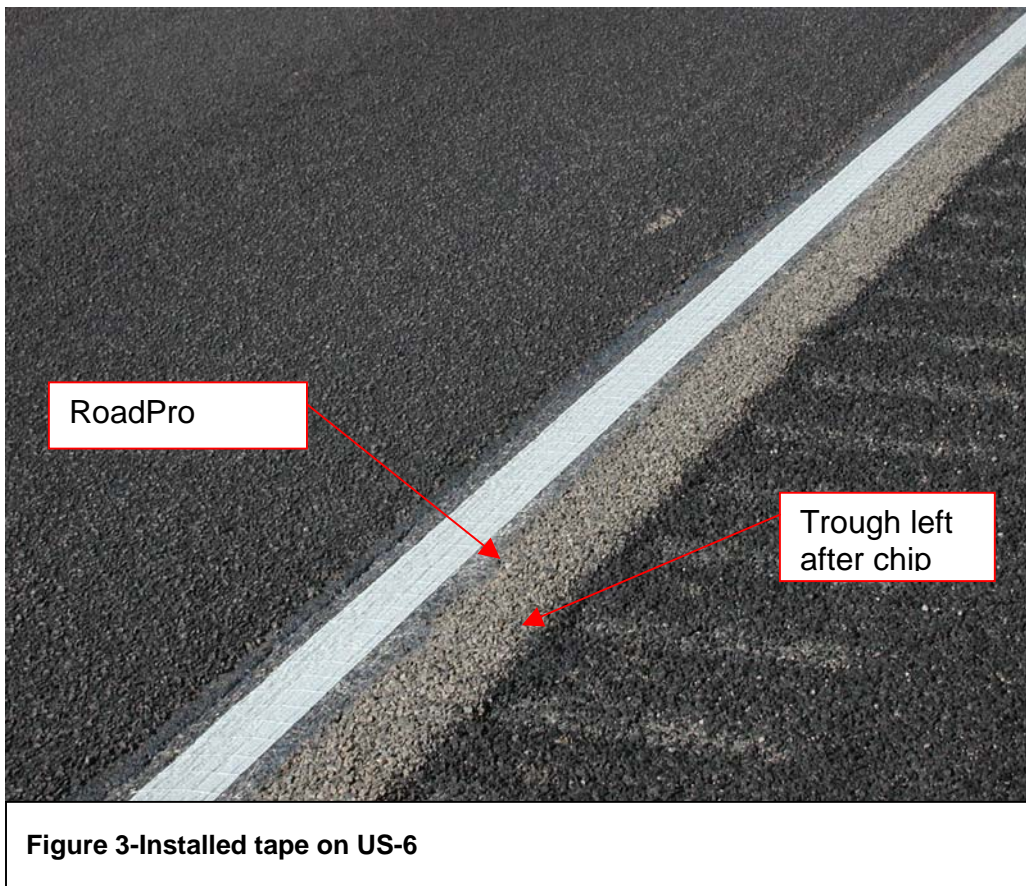
placed over the existing asphalt surface, but the oil sprayers were turned off over the tape location. This allowed the excess chips to be swept away and a trough was left where the tape was going to be placed. Then, a Roadpro asphalt grinder was used to increase the depth of the inlay and to make a more precise groove. The surface was then sprayed with the 3M primer, the paper backing removed, and the product placed. Compacting rollers were not used on this job; instead, a car wheel and a truck wheel were driven over the product to press it. Figure 3 shows the end product.

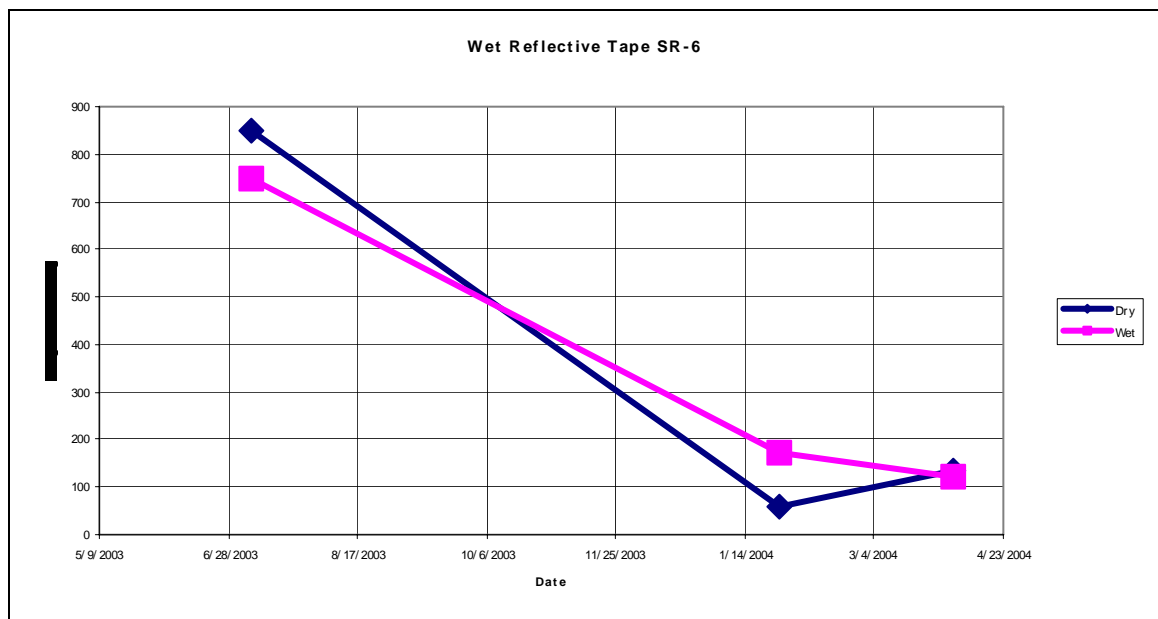
1. The initial retro reflectivity was very good. However, there was a large standard deviation in the data. The data shows a dramatic decline in the RR over the first season. The wet-night retro reflectivity was measured using the LTL 2000 and showed good results.

The chart shows the dramatic decline. Interestingly, the values doubled or sometimes tripled if the RR was measured against the flow of traffic. This hasn't been explained, but may indicate the product is more sensitive to snow plow abrasion than other markings.

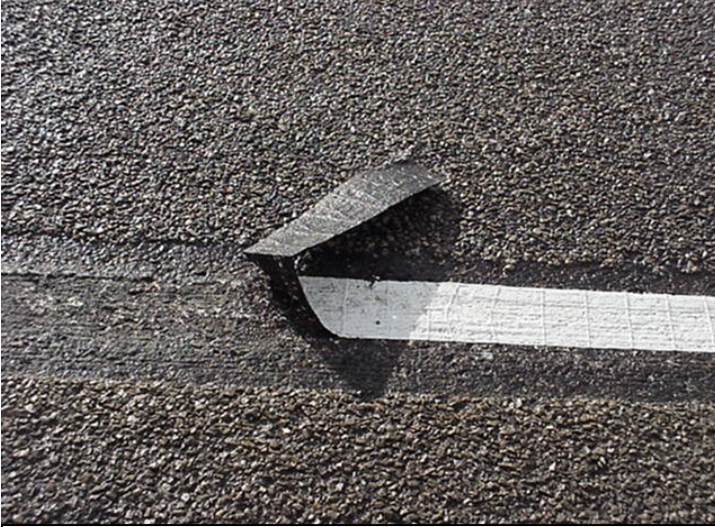
2. There was a major problem with the durability. In both locations there were major portions that came up. The total loss amounted to about 10% of the total project. The reason for the loss isn't yet known. Warranty work will be done to replace the failed tape.
3. Warranty work was performed by 3M and because the redo involved significant replacement at both sites the study was discontinued. Evaluating old and new is not practical and yields mixed results.

Figure 0-Failed tape on SR-6

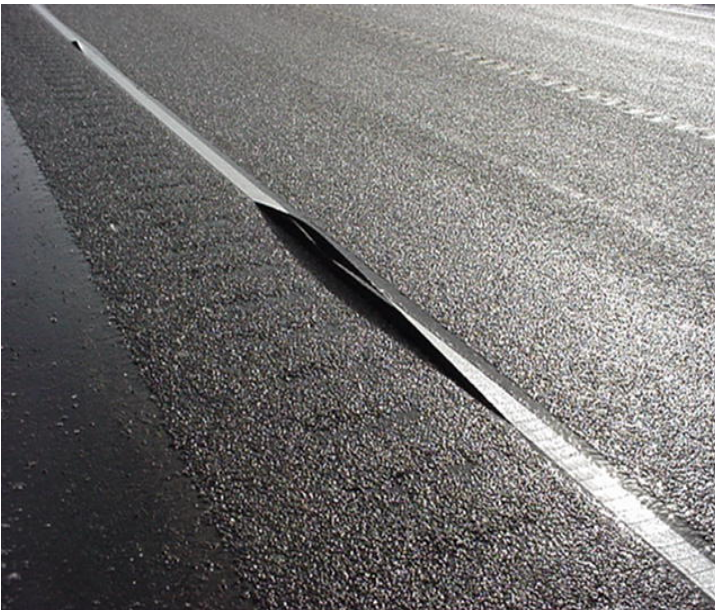
Figure 0-Failed tape on SR-6

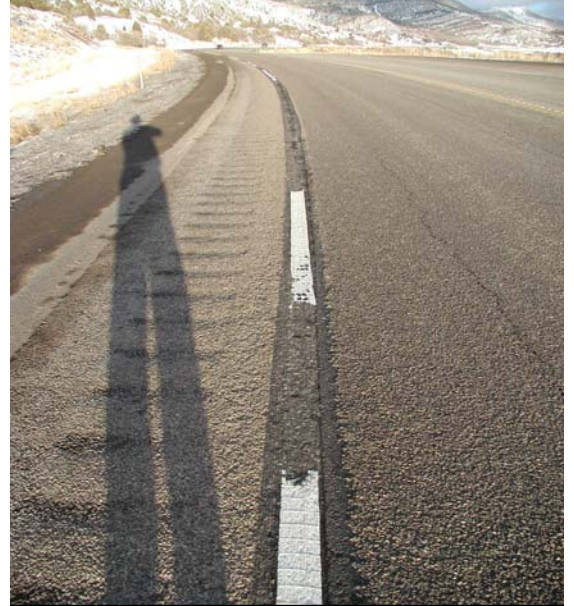
Figure 0-Failed tape on SR-6

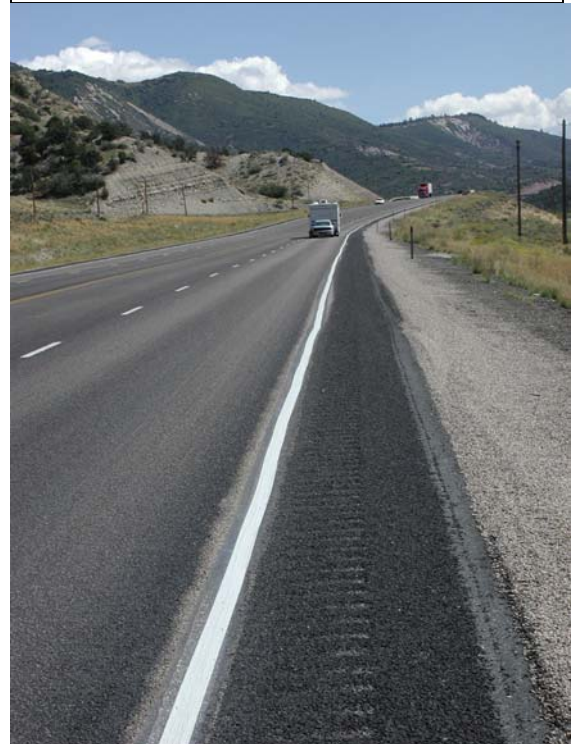
Figure 0-90% typical tape on SR-6
